Inspection Report

Property Address:
23 McDonald Court
Flamborough ON

BLT Home Inspections

Date: 18/01/2013	Time: 09:00 AM	Report ID:
Property: 23 McDonald Court Flamborough ON	Customer: Bruce Treacy	Real Estate Professional:

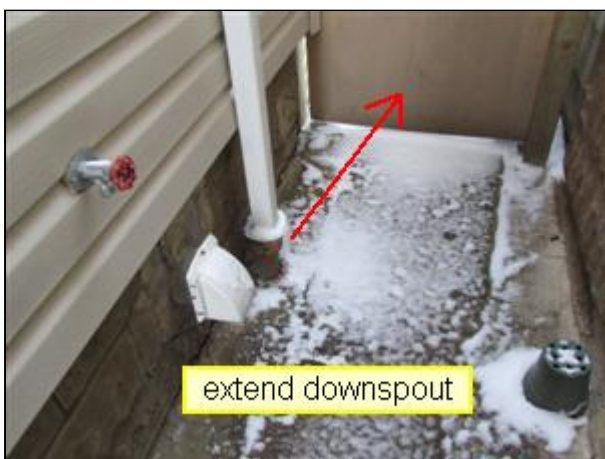
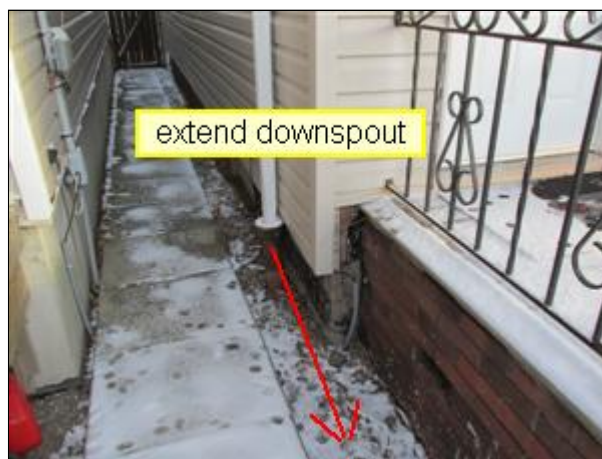
The downspout(s) located on the west and east side discharge(s) water below grade. Downspouts should discharge water above grade to assist in preventing water seepage into the basement or crawl space due to drain line blockages. Call a qualified person to extend the downspout at least 6 ft away from the foundation, seal off the drain line extending below ground. Time frame, regular maintenance.

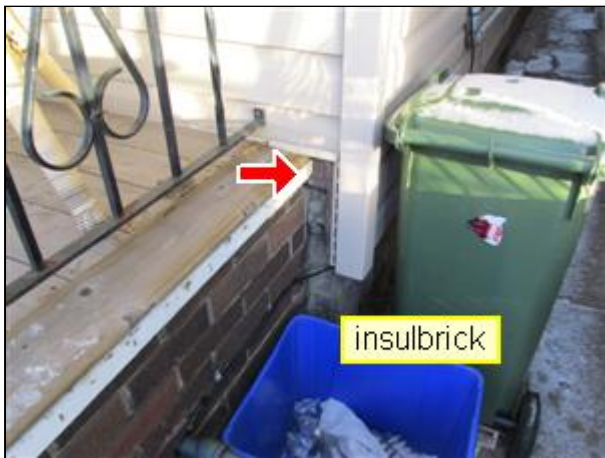
2.0 Item 1(Picture)

The original siding appears to be insulbrick and has been covered with vinyl siding. (FYI)

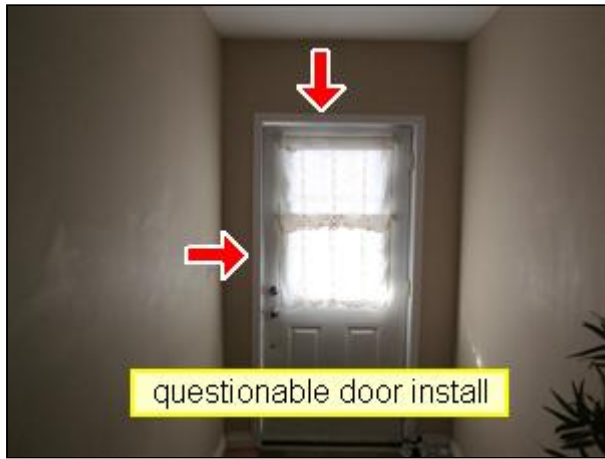
2.1 Item 1(Picture)

The installation of the front door, gaps were observed around the perimeter, the door was not in contact with the weather stripping allowing drafts to enter the house, therefore increasing energy costs. Call a licensed door installer for evaluation, possible rehanging or installing a new weather stripping system. Time frame within 6 months.

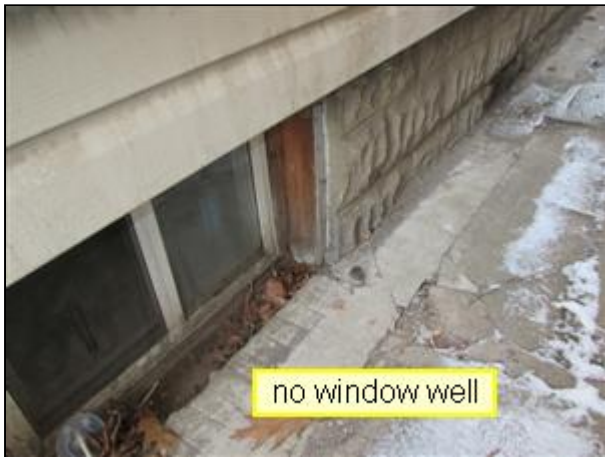
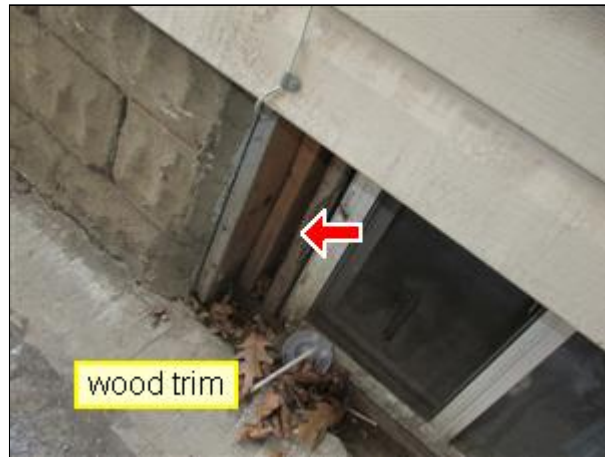
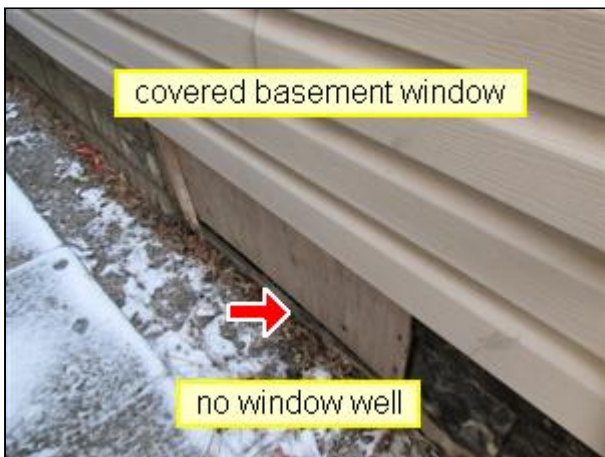
The basement windows are close and/or at grade level and water entry into the basement area through the windows is possible. I recommend that window wells and covers be installed over the basement windows and the soil depth at least 6 inches below the window sill to assist in preventing water entry into the basement area. This window well cover will keep debris out of the well and reduce the possibility of leakage through the window into the basement. The wells should be secured and caulked to the foundation. Time frame within 2 year.

The basement windows are wood trim and deteriorating, repair is required before further deterioration takes place. Caulking and painting are required around the frame to stop water infiltration into the basement area. Call a qualified person to inspect and repair the windows.

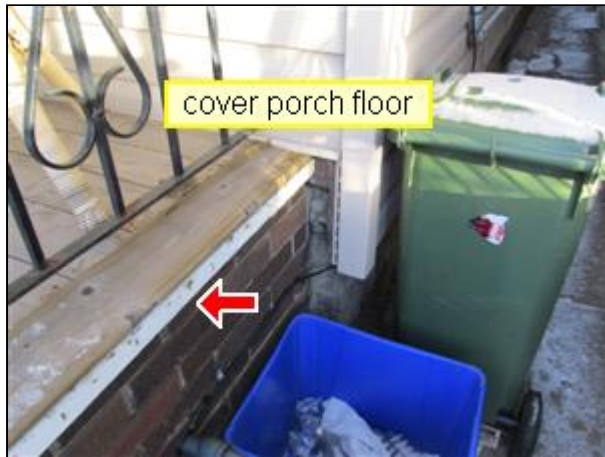
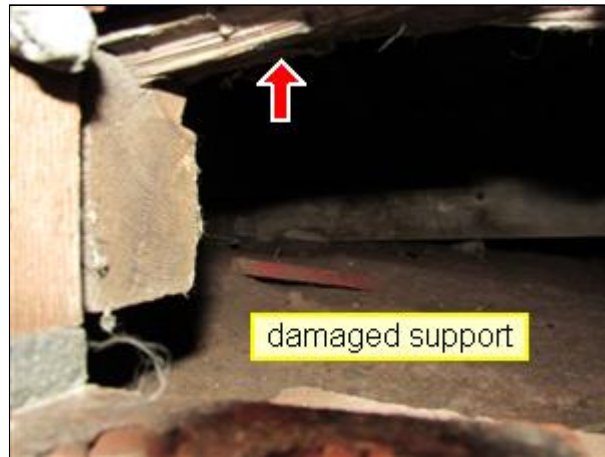
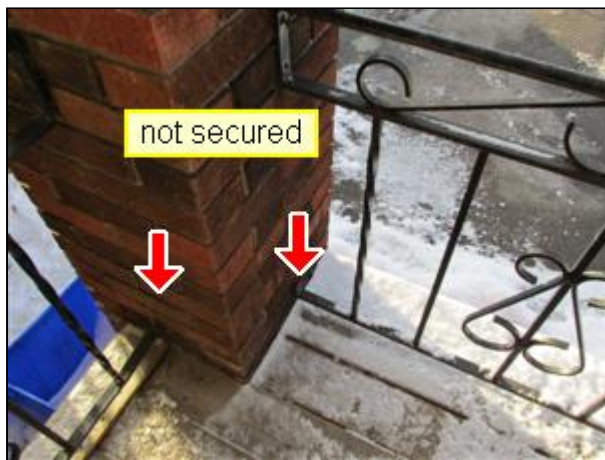
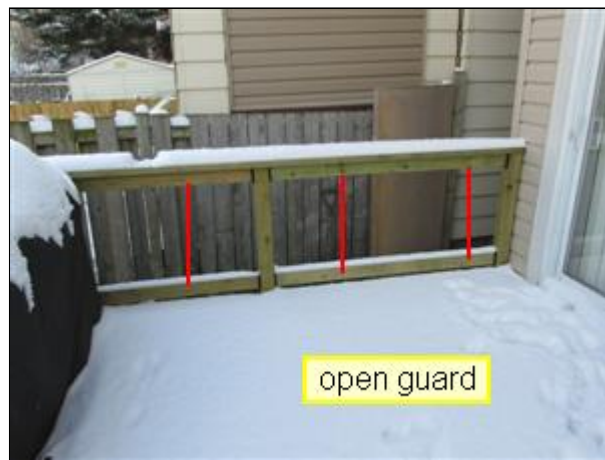
There is a damaged floor joist under the front porch, visible inspection was restricted, further investigation is required in regards to the condition of the wood structure, future renovations maybe required.

The metal railing is not secured at the bottom to the brick column, potential safety hazard. Call a qualified person to secure the railing, time frame within 6 months.

The handrail around the back deck does not have guards for preventing falls from the deck floor, personnel safety hazard. Call a licensed deck installer to install a barrier or vertical guards along the handrail, time frame within 6 months.

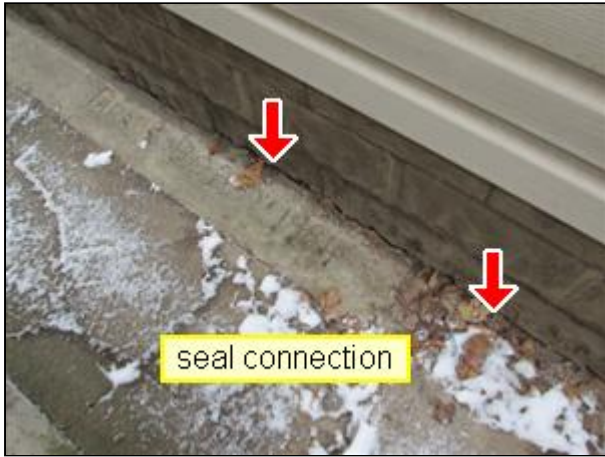
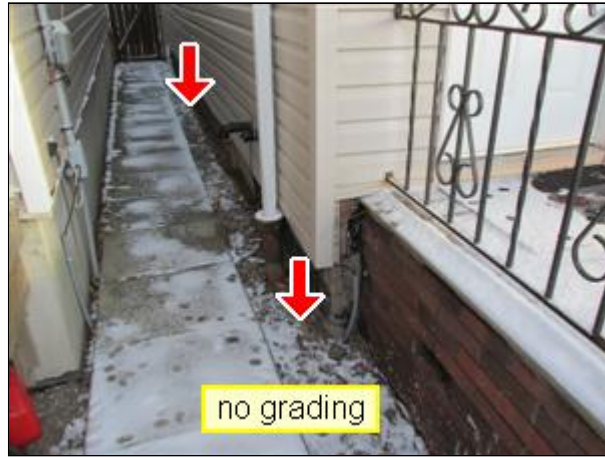
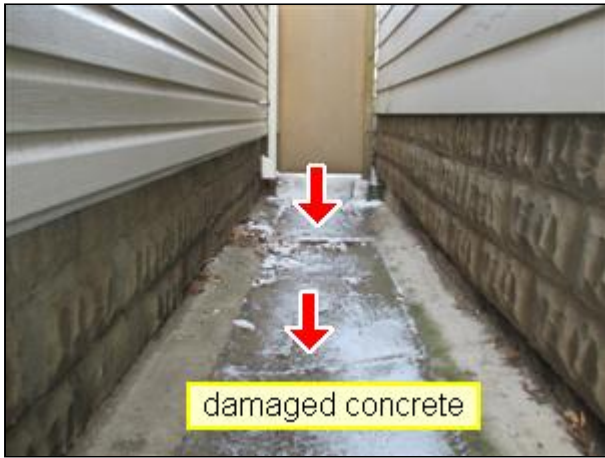
There is a gap between the concrete walkway and the foundation located on the east side, water seepage down and along the foundation is possible, entry through the block foundation into the basement area is also possible. Seal the gap along the foundation with a suitable caulking compound. Time frame within 6 months

The area between the concrete walkway and foundation is filled with stone. The area is not graded away from the foundation, water will be directed down and along the foundation and could possibly seep into the basement area. Create a positive grade directing water away, call a licensed contractor familiar concrete or asphalt for evaluation. Time frame within 1years.

The concrete walkway between the two houses has heaved and may inhibit drainage away from the foundation. Water can seep between the cracks and displaced pieces and could enter the basement area. Call a licensed concrete or asphalt contractor to repair the walkway ensuring a positive grade for drainage, time frame within 2 years.

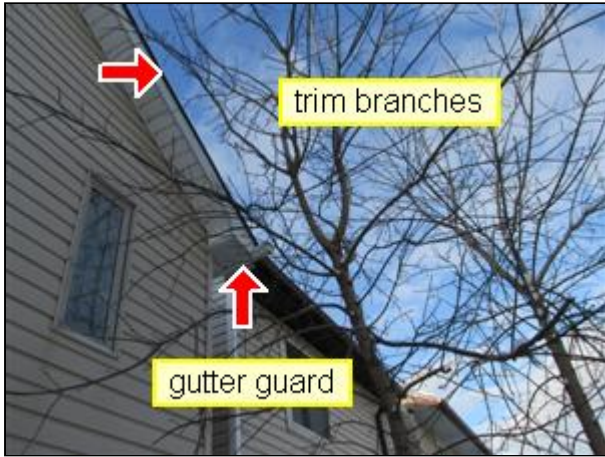
2.5 Item 1(Picture)

Debris from the deciduous tree can block the drainage of the gutter and cause water backups into the soffit area and possibly into the interior ceiling and wall. Over spillage of the gutter system can cause excess water to accumulate close to the foundation, possibly causing seepage into the basement area. Install gutter guards where required. Time frame regular maintenance.

Trim back any branches that are in contact with the siding or roof covering. (FYI)

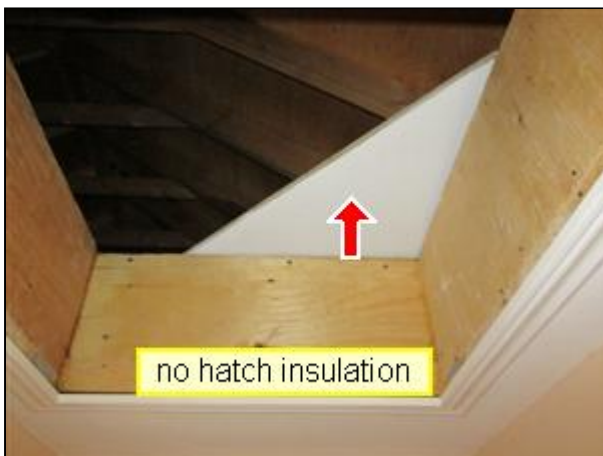
4.0 Item 1(Picture)

The attic hatch is not insulated, the hatch requires insulating to stop heat loss into the attic space. I recommend insulating the attic hatch and ensuring the hatch seal around the perimeter in is good condition to prevent warm air escaping into the attic. Time frame 6 months.

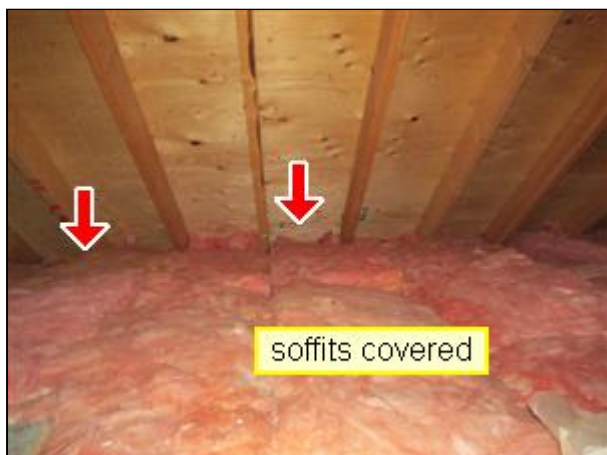
4.3 Item 1(Picture)

The insulation appears to be covering the existing soffit vents and no baffles were visible resulting in poor air flow. Increase soffit and roof venting to improve air flow ventilation and reduce heat build up which can reduce shingle life and possibly damage roof sheathing. Call a licensed insulation or roofing contractor for evaluation and repair. Time frame within 1 year.

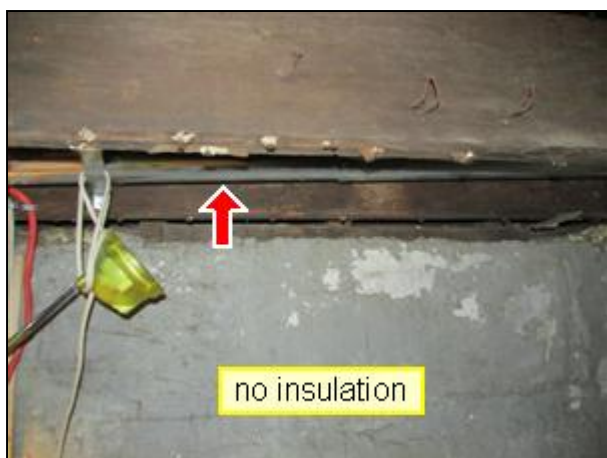
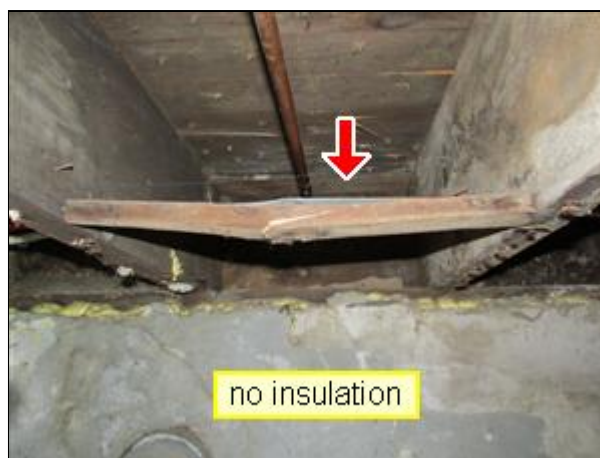
The floor headers are not insulated, heat loss and drafts through the headers is an area of concern when considering overall house energy efficiency. Insulate the headers to conserve energy, call a licensed insulation contractor for evaluation. Time frame within 2 years.

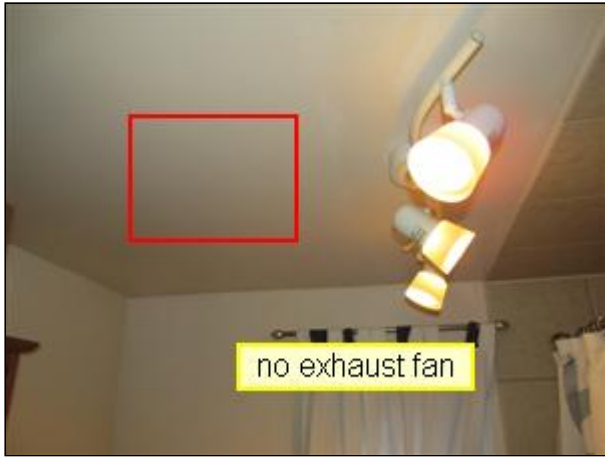
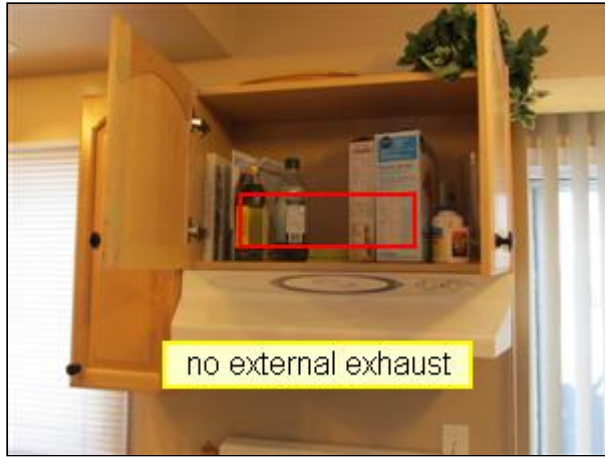
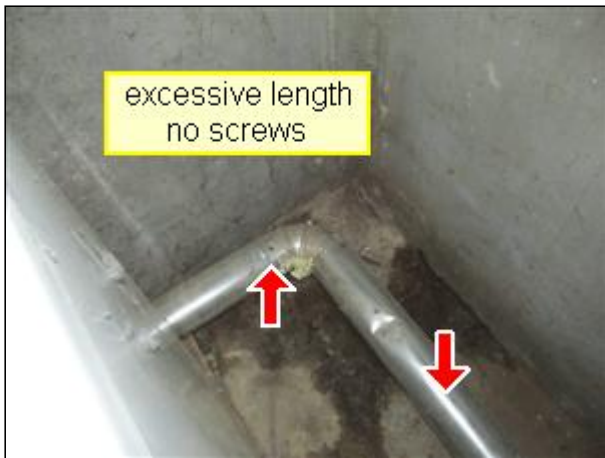
The bathroom on the main floor does not have an exhaust fan. Exhaust fans assist in removing excess moisture and odours from the home helping to create a healthy environment. Excess moisture in the home can create a habitat for mould formation. Exhaust fans are desirable in addition to window ventilation. Call a licensed electrician to evaluate and install an exhaust fan. Time frame, discretionary item.

The kitchen does not have an exhaust fan to eliminate moist air to the exterior. Excessive moisture in the house can cause air quality and mould issues, damage the interior cosmetic appearance of the building envelope. Call a licensed electrician to install a kitchen exhaust fan exhausting to the exterior. Discretionary item. Recirculating fans may also be installed, however, they will not expel odours and moisture to the exterior. Time frame discretionary item.

The drier vent is excessive in length, efficiency in removing the drier air maybe compromised and lint buildup is more likely. Shorten the vent length to approximately 10 ft, relocation of the drier maybe required. Call a qualified person to perform the work, time frame is within 6 months.

The drier vent connector is secured with screws, screws can collect lint and create a buildup of lint. The buildup of lint can produce a fire hazard, remove the screws and secure the connections with aluminum duct tape. Time frame within 6 months.

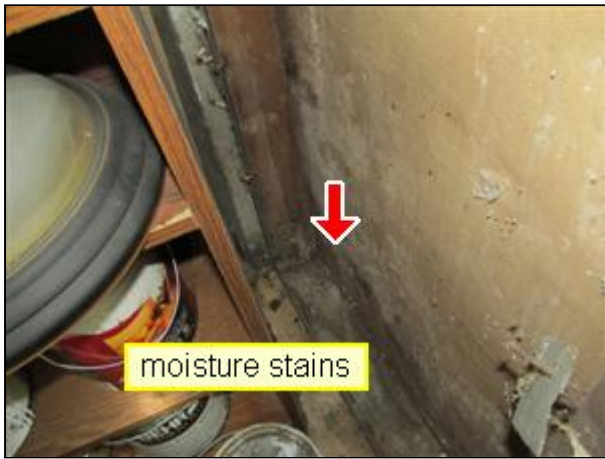
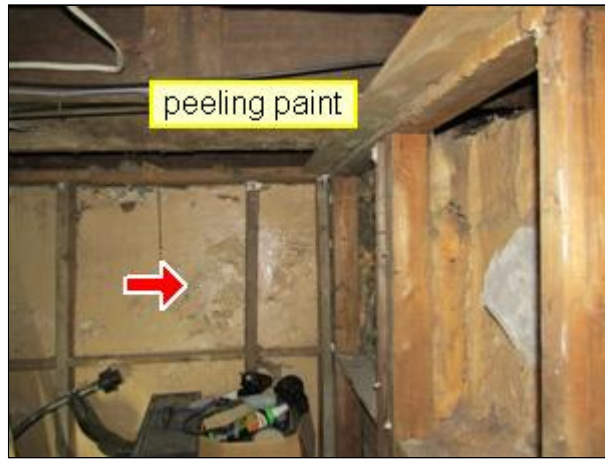
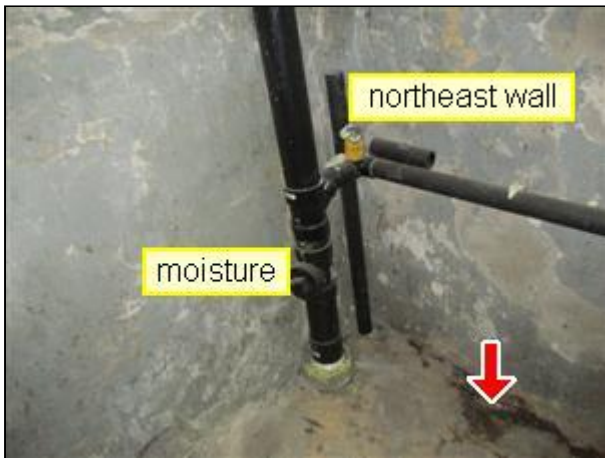
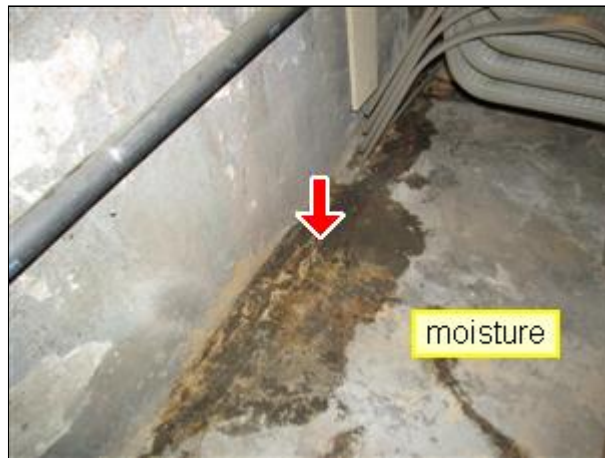
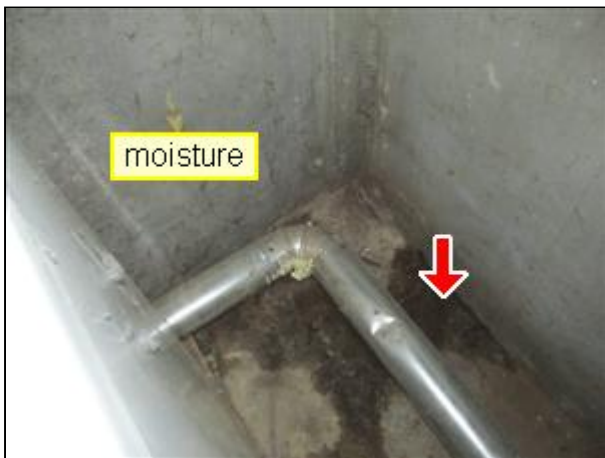
The basement walls show signs of moisture seepage, peeling paint on the walls, moisture stains on the wood bottom plates.

There was water seepage in the basement, check the outside drainage, downspouts discharge above ground, seal any gaps around the perimeter of the foundation ensure grading and concrete walkways have positive drainage and do not allow water to seep below grade. Call a licensed basement contractor for further evaluation, time frame prior to performing any renovations.

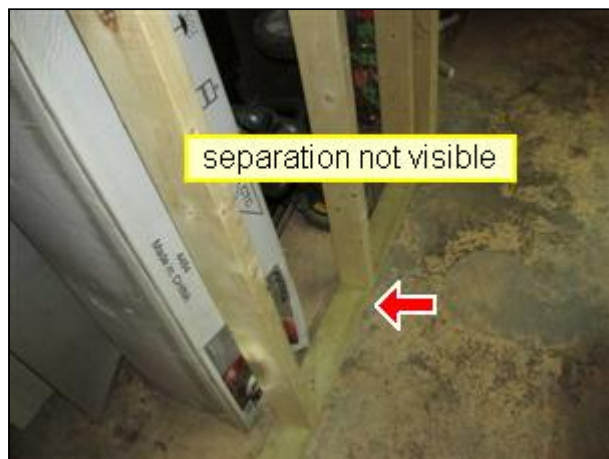
5.1 Item 1(Picture)

The stud wall located in the basement, no visible gasket material was observed. A separation between the bottom plate and concrete is required to stop moisture from migrating from the concrete to the wall plate, wood rot and mold formation are possible. Call a qualified person to repair the stud wall and install gasket material under the bottom plate.

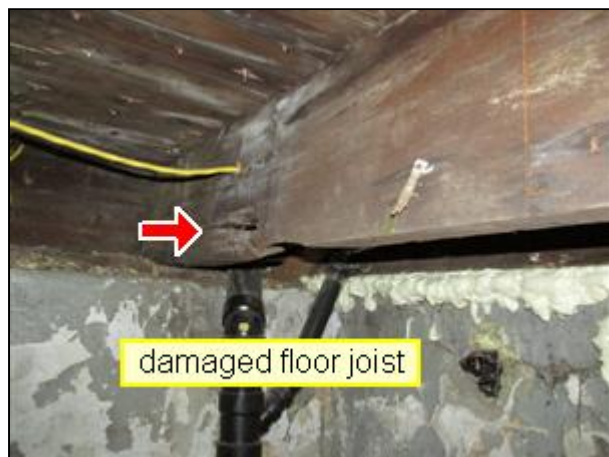
5.3 Item 1(Picture)

The floor joist located in the basement has been damaged (cracked), structural integrity of the floor maybe compromised in that area, sistering of the existing joists maybe required if sagging is observed or cracking of any ceramic tile or grout. Call a licensed carpenter for evaluation, time frame unpredictable.

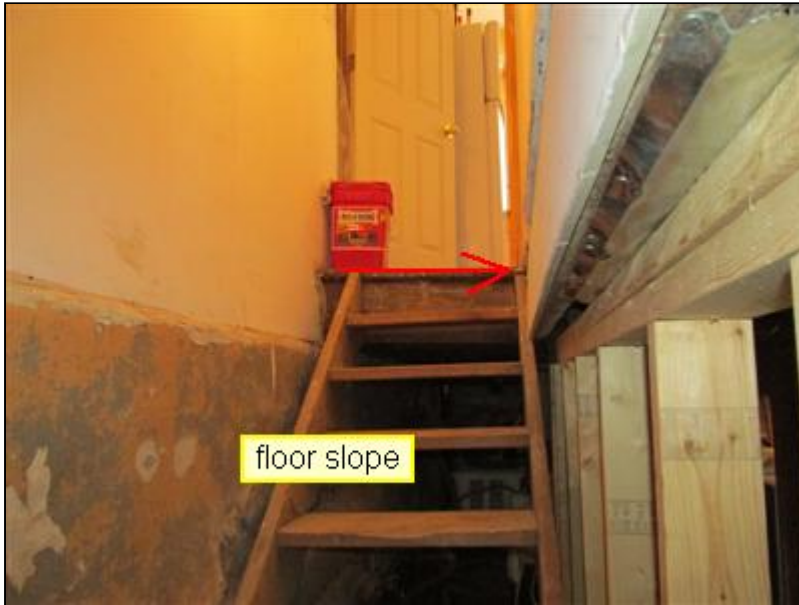
6.2 Item 1(Picture)

The floor slopes toward the inside as does the floor joist supporting the floor. The 2x6 and 2x4 wall in the basement appear to be structural supports to prevent further sagging. Consult a licensed carpenter familiar with structural support if the ceramic tiles crack or prior to removal of the installed stud walls.

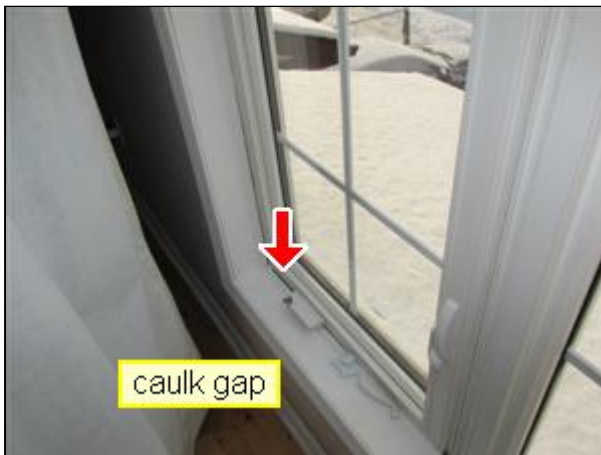
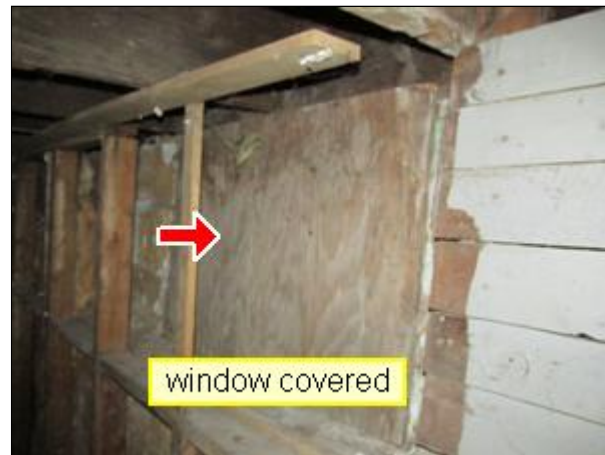
Caulk the gap around the window to prevent drafts from entering the house, visually inspect all interior windows for gaps, caulk all gaps, time frame regular maintenance.

Some basement windows have been covered with plywood on the interior and exterior, drafts were evident resulting in an increase in energy costs and cool basement area. Install basement windows or seal the existing windows preventing drafts from entering the basement area. Call a licensed window contractor for evaluation, time frame within 2 years.

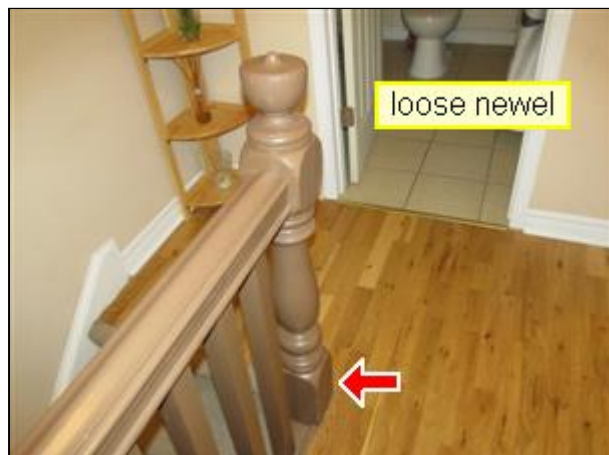
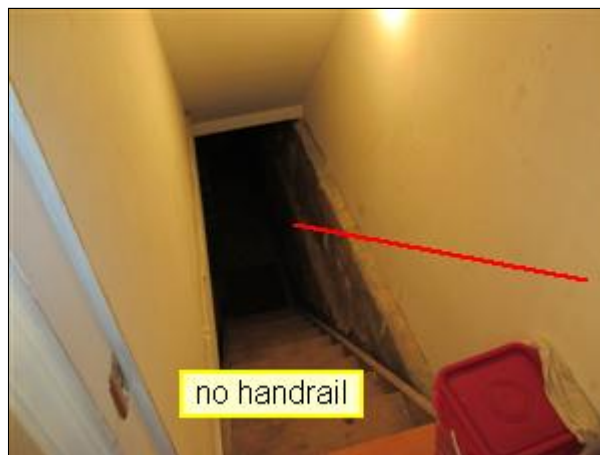
The newel located on the second floor is loose resulting in a loose handrail/guard protecting the stairway, stair safety and personnel injury are a concern. Call a qualified person to secure the newel. Time frame within 6 months

The stairway from the main floor to the basement does not have a handrail. Handrails are required for stair safety and assist in preventing falls and personnel injury. Call a qualified person to install a hand rail. Time frame within 1 year.

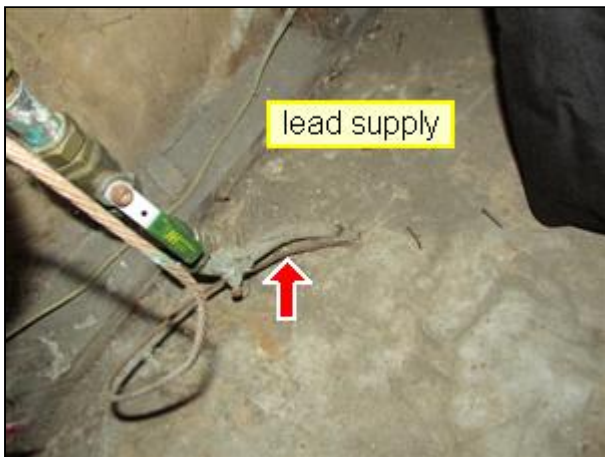
7.1 Item 1(Picture)

The pipe that supplies the water to this house from the municipal water system is made of lead or lead bearing material. Lead pipes leach lead into the water supply. Lead can cause medical problems, particularly for infants and children. I recommend replacing the lead supply pipe with a 3/4 inch copper pipe, or installing a lead filtration system, time frame within 1 year.

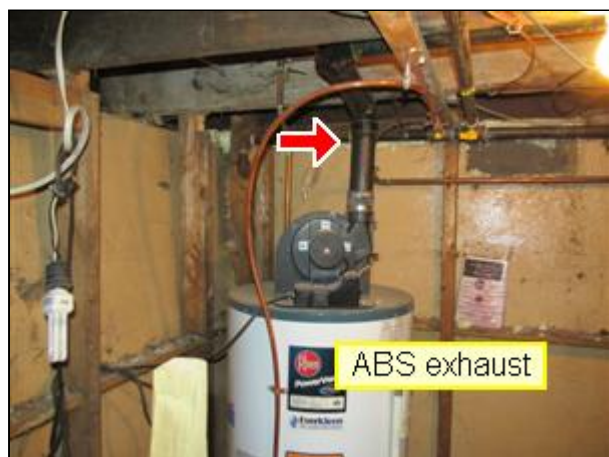
7.2 Item 1(Picture)

The material ABS used for the exhaust vent for power vented water heaters is a concern, structural stability is a concern, cracking is an issue, safety is an issue and the presence of CO fumes escaping. Call a licensed HVAC technician to inspect the exhaust material, changing the vent material maybe required. Time frame, prior to use.

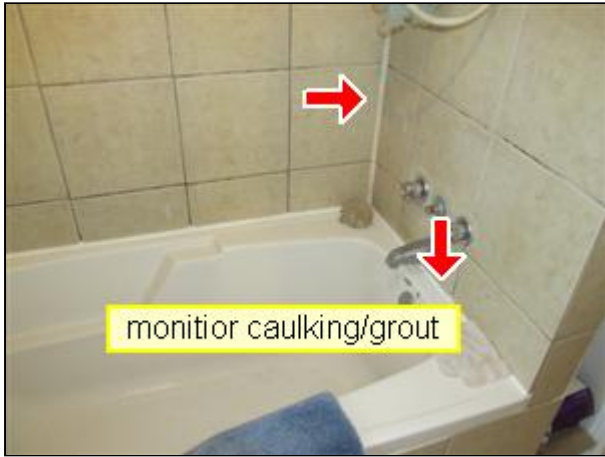
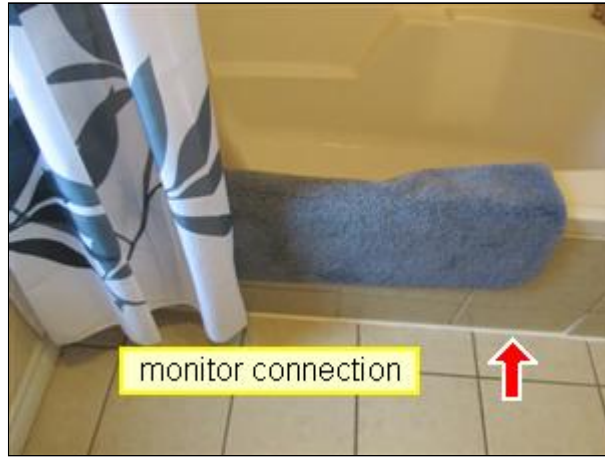
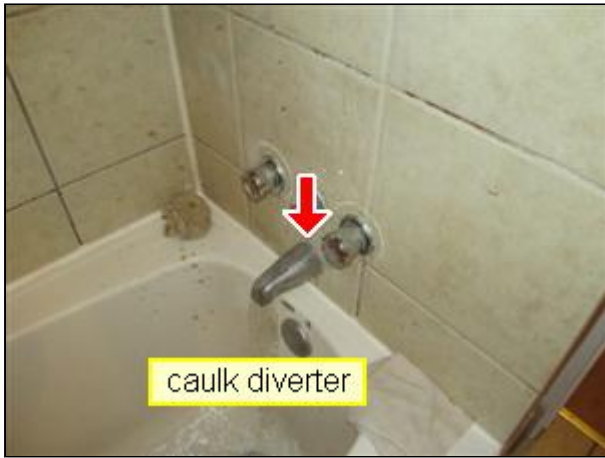
The connection between the bathtub and floor should be monitored for cracks, gaps to prevent water seepage to the underlying ceiling, resulting in cosmetic damage. In addition, monitor all caulking and grout for cracks or gaps, repair all cracks or gaps. Regular maintenance item.

The caulking and grout should be monitored for cracks, gaps which will allow water to penetrate into the floor and wall system causing cosmetic and structural damage. Repair any cracks or gaps in the caulking and grout. Regular maintenance.

There is a gap between the diverter the ceramic tile wall. Water can infiltrate into the wall cavity through the gap and cause damage to the wall structure and possibly form mould. Caulk around the diverter. Time frame within 6 months.

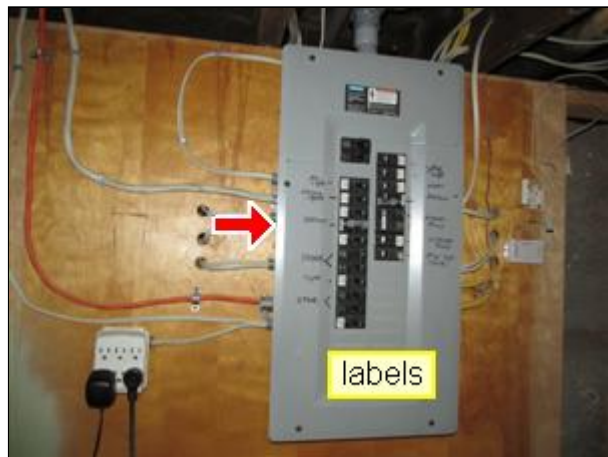
13.3 Item 1(Picture)

Panel labels, (identification) should be checked and verified for safety purposes.

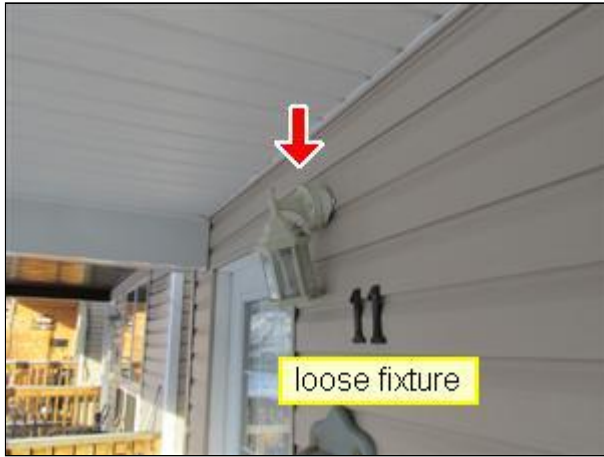
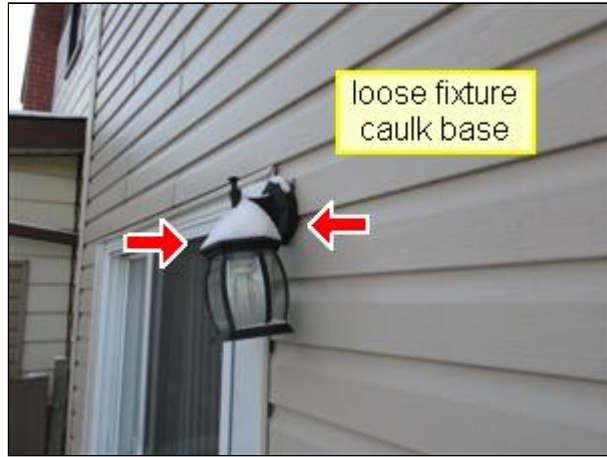
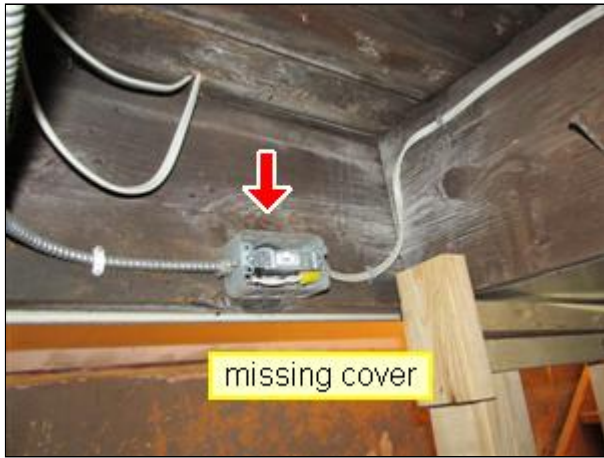
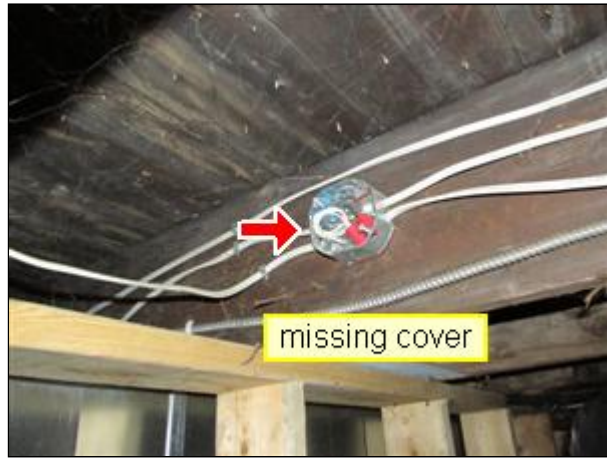
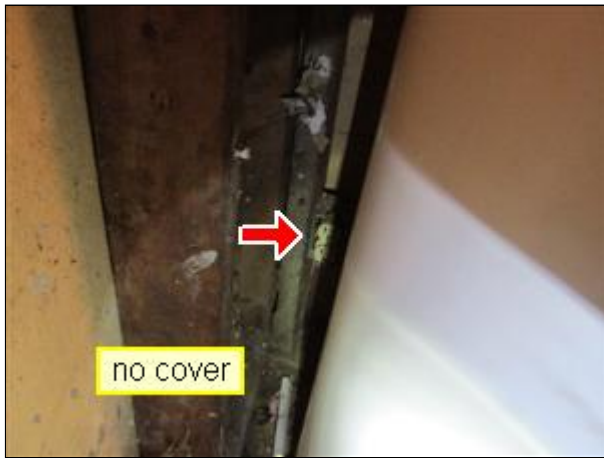
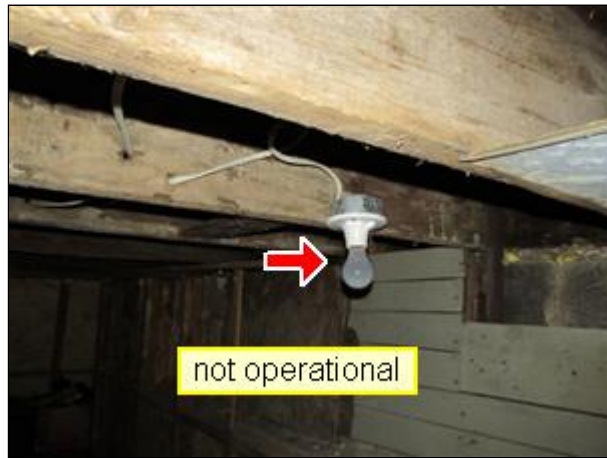
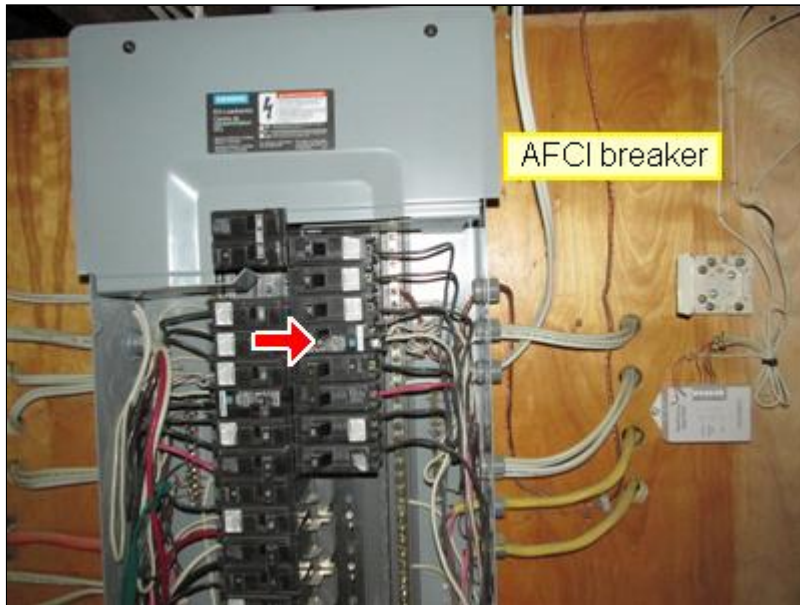
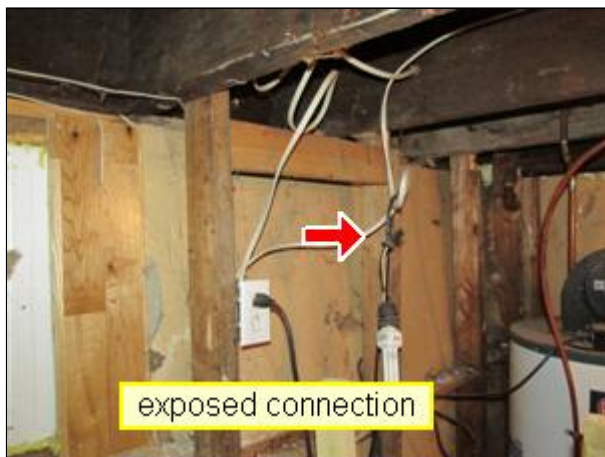
The exterior lights, gaps were visible between the light base and the wall. Water (moisture) penetration into the junction box is possible causing the corrosion and possibly an electrical short circuit. Caulk around all exterior light bases to seal the gap. Time frame within 1 year.

There are electrical switches and junction boxes that do not have a covers, live electrical connections are exposed, electrical safety hazard. Install an electrical cover, ASAP.

Pull chain lights are not allowed in damp locations, electrical safety hazard. Replace the pull chain with a switch controlled light, call a licensed electrician. Time frame within 6 months.

There are live electrical connections that are not contained in a junction box, electrical safety and personnel injury at risk. All electrical connections are required to be secured in an electrical junction box for safety, call a licensed electrician to perform the necessary repairs, time frame immediate.

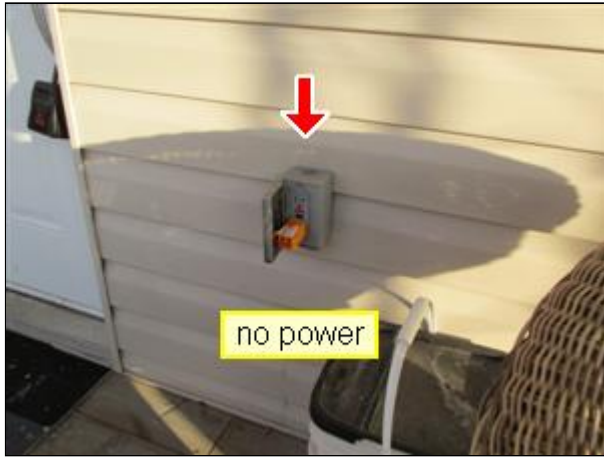
13.6 Item 1(Picture)

The GFI located in the back has no power, further investigation is required by a licensed electrician. Time frame within 6 months.

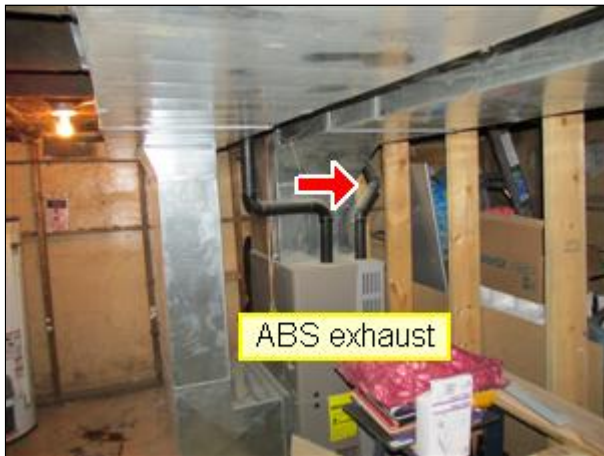
14.0 Item 1(Picture)

The material ABS used for exhaust systems with high efficiency furnaces should be inspected by a licensed HVAC technician for structural stability, cracking is an issue, safety is a concern, CO fumes escaping, the material should be changed to the current acceptable material. Time frame, prior to use

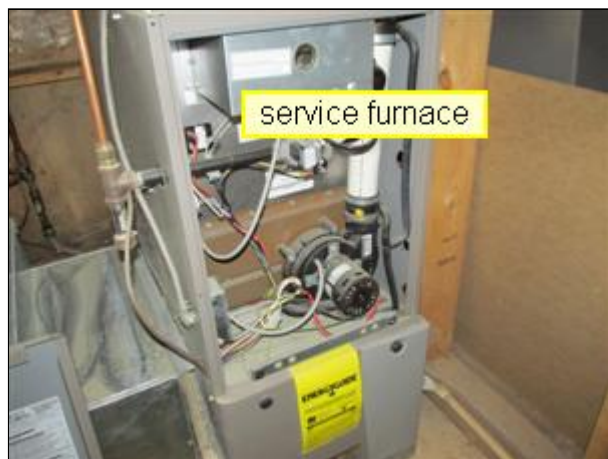
14.2 Item 1(Picture)

The furnace was visually inspected and there were no visible signs of a maintenance schedule detailing repairs or service. Service is recommended by a licensed HVAC technician prior to use to ensure safe operation, check for CO leakage and efficient operation.

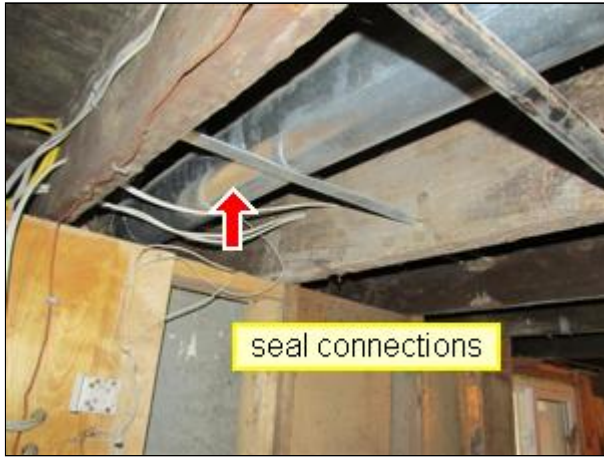
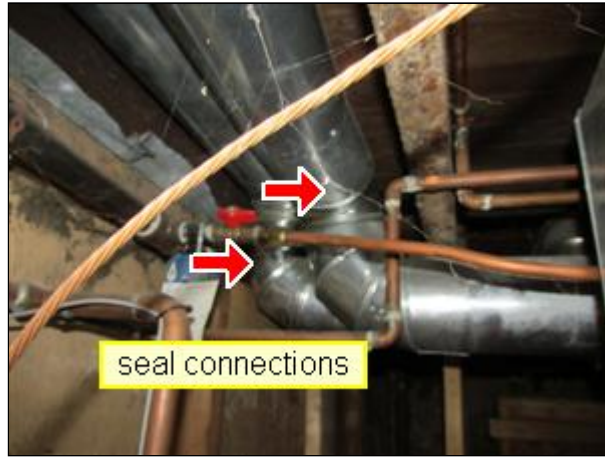
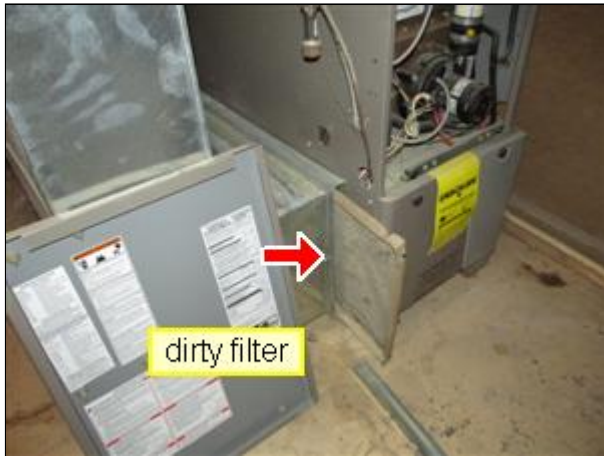
The heating and cooling ducts, plenums, the connections are loose, gaps maybe present and they are not sealed. Air flow will escape through the connections, efficiency will be affected. Seal all visible duct and plenum connections with aluminum duct tape to ensure more efficient air flow. Regular maintenance item. Regular maintenance item.

The furnace filter is dirty, dirty filters can reduce furnace and air conditioning efficiency, increase energy costs and create mechanical strain on the blower motor. Change the filter on a regular time basis based upon filter inspection.
